# Manhole Inspection Summary

Manhole # S07II2004MH

Insp Date: **10/2/06 2:20 PM**

**Location** Address: **6304 GREEN MEADOW PKWY**

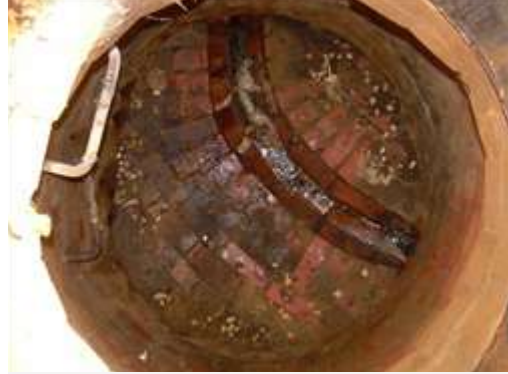
Top View

Evidence of surcharge - Bench debris.  
Channel debris.

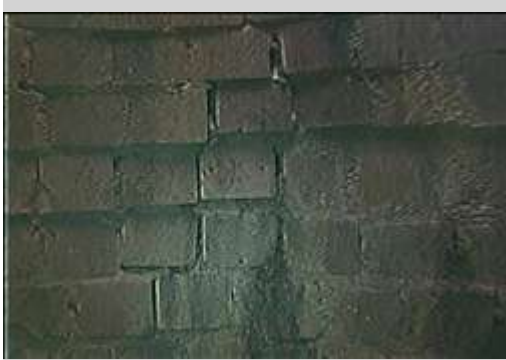
Defect

Condition: ☐ Sound ☐ Cracked ☐ Root Intrusion ☐ Loose Brick ☒ **Deteriorated**

Infiltration: ☐ None ☐ Joint ☐ Cracks ☒ **Mortar** ☐ Roots ☐ Wall

Infiltration: ☐ None ☐ Joint ☐ Cracks ☒ **Mortar** ☐ Roots ☒ **Wall**

Corbel and Barrel deterioration and  
infiltration.

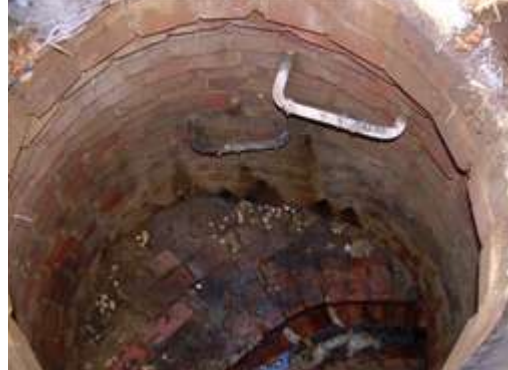
Defect

Condition: ☐ Sound ☐ Cracked ☐ Root Intrusion ☐ Loose Brick ☒ **Deteriorated**

Infiltration: ☐ None ☒ **Joint** ☐ Cracks ☒ **Mortar** ☐ Roots ☐ Wall

Adjustment deterioration and infiltration.  
Barrel infiltration.

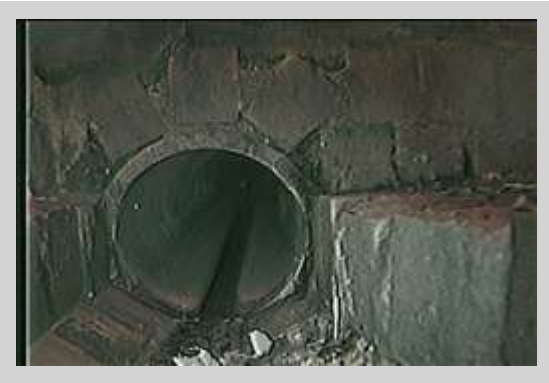
### 8 in. Circular Gravity Sewer Pipe Out @ 12 O'Clock

Barrel deterioration and infiltration.

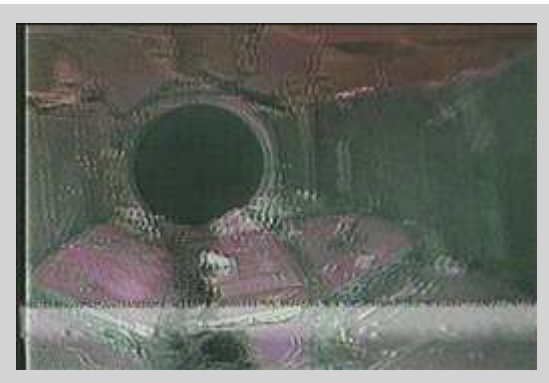
### 6 in. Circular Gravity Sewer Pipe In @ 4 O'Clock

Condition: ☐ Sound ☐ Cracked ☐ Root Intrusion ☒ **Deteriorated** ☐ Leaks ☐ Debris

Channel deterioration.
